The Grate Solution: Simplifying Viking Oven Packaging Processes

By
Megan Jansen

A thesis submitted to the faculty of The University of Mississippi in partial fulfillment of the requirements of the Sally McDonnell Barksdale Honors College.

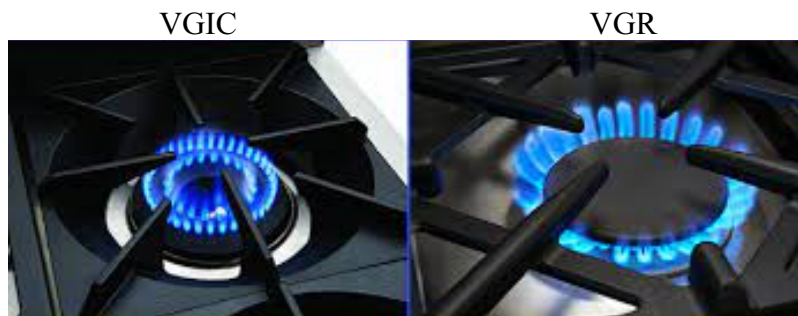
Figure 1: Two Types of Burners

My team dealt specifically with Viking's gas oven side of the plant. No matter the shape or size, all Viking gas ovens are either sealed burner (VGR) or open burner (VGIC). Figure 1 depicts the difference between the two types of burners.

The only differences between the two types of burners on the manufacturing side are in the final packaging stage. The VGR ovens receive one VGR specific middle grate and a burner bowl and VGR specific grate for each burner on the stove. The VGIC ovens receive one VGIC middle grate and a burner cover and VGIC grate per burner. Each Viking gas oven is custom made to order and all of the gas ovens are made on the same assembly line.

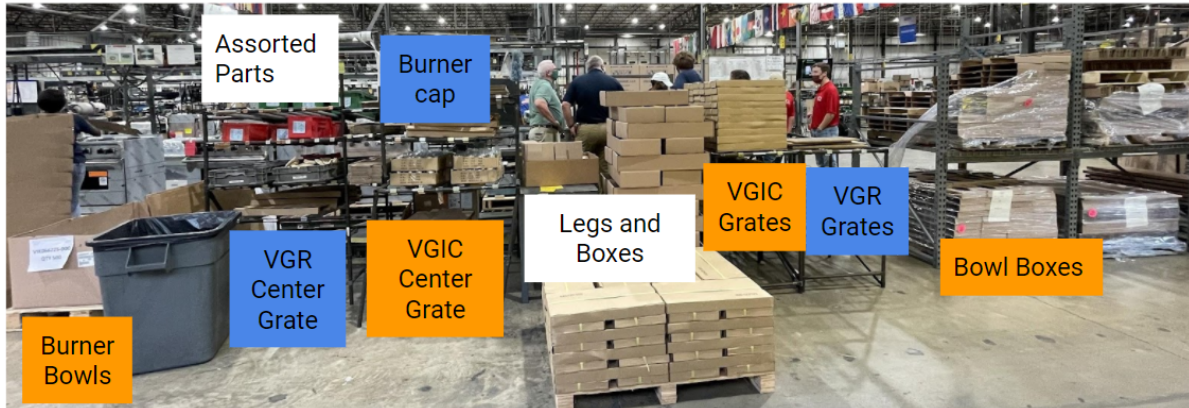
Figure 2: Current Packaging Station Set Up

The current method of packaging each individual stove's kit is unorganized and relies heavily on operator memory. While zero operator error is always the goal, the current setup at Viking makes it extremely easy for operators to accidentally select the wrong prepackaged grate. After talking to numerous assembly line operators, it was apparent that there was a problem in the system. Figure 2 illustrates how the VGR and VGIC parts are intermixed on the assembly

Key: Orange: VGIC Blue: VGR

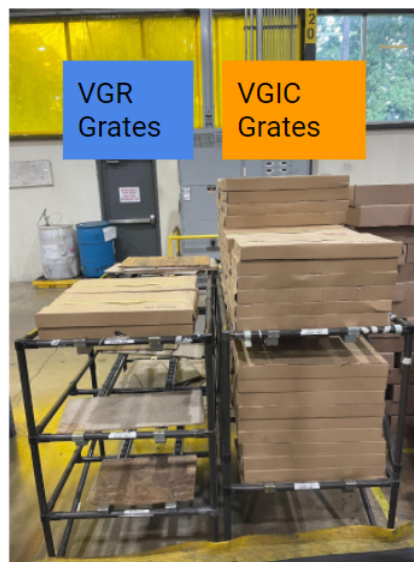
Figure 3: Current Packaging Station Grate Set Up

line. Figure 3 shows the operator's view of the different grates. Figure 4 shows how similarly the different grates are packaged, allowing the operator to easily mistake a VGR grate for a VGIC grate and vice versa.

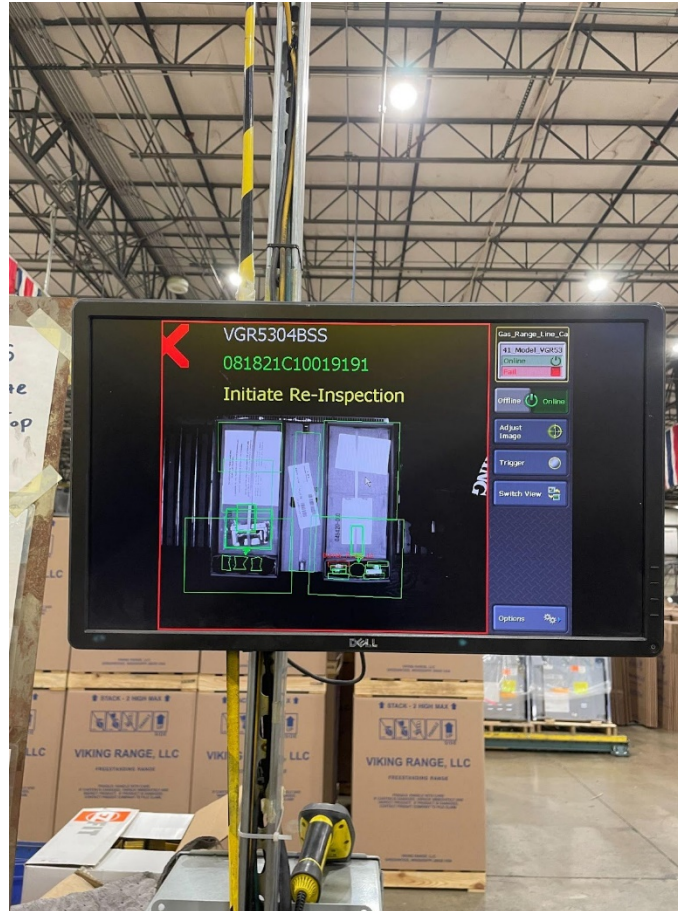
Figure 5: Quality Check Visual System

At the end of the assembly line, Viking has a visual system quality check in place to verify that the correct number of boxes have been included with each oven. The system makes sure the burner bowls and grates are in place. However, because the boxes are so similar for the different types of grates, the camera can ensure only that the boxes are present but cannot verify that the boxes are the correct type. Figure 5 depicts the visual system quality check in place.

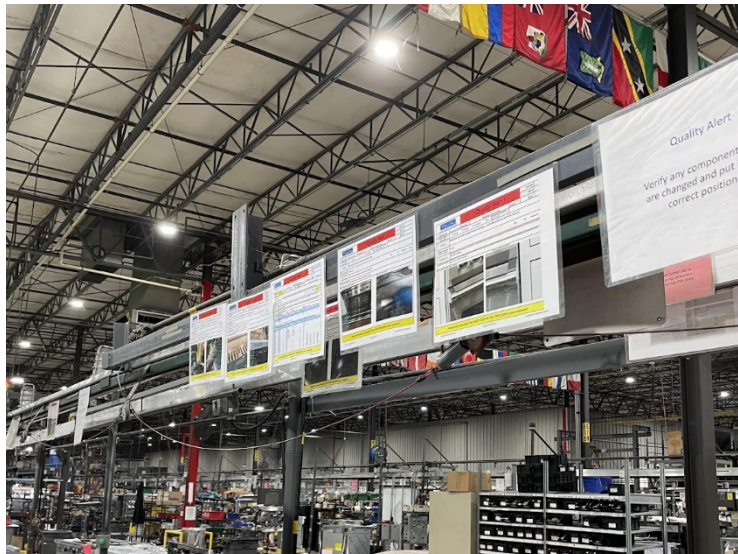
Figure 7: Quality Check on Assembly Line

The first interim containment strategy was to add an additional quality alert to the line. Quality alerts bring an issue to the attention of line operators and keep it in the forefront of their mind. While even some experienced team members may not refer to the quality alert every time, new or temporary workers would definitely refer back to it. In manufacturing, an assembly line cannot function with even one member missing. Therefore, if an operator is sick or not able to come to work, another person will be placed in the position. The quality alert will help ensure that the new operator is paying close attention to risky areas of the process. It is also a no-cost process, so even if it prevents one grate from being mismatched, it will have saved the company money. Figure 7 illustrates an example of a current quality check that Viking has in place on the assembly line.

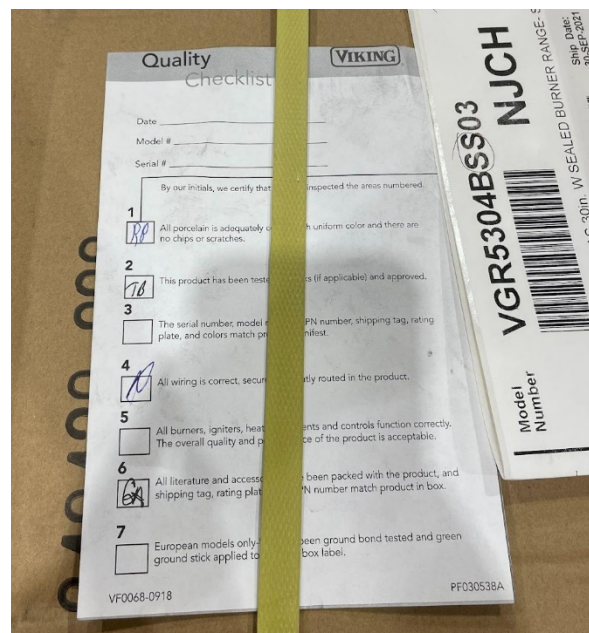
Figure 8: Pre-Existing Quality Check Sheet

Our final no cost interim containment was an eighth quality check on the preexisting quality check sheet. The eighth check would state, “all grates match the part numbers called out in the bill of materials.” This checkbox would require a signoff before being packaged up and sent to the customer. Figure 8 depicts the already existing quality check sheet that gets sent down the assembly line with each oven.

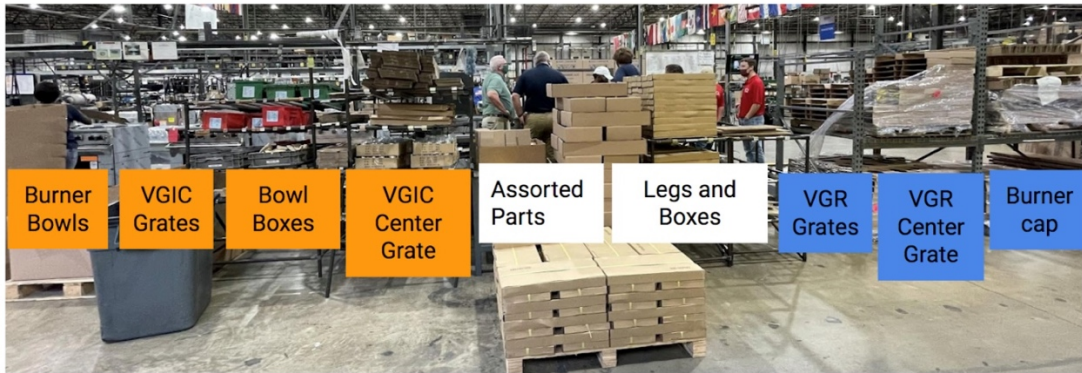
Figure 11: Proposed Part Layout

Figure 11 illustrates the proposed layout. Not only does this set up reduce the operator's transportation time and transportation waste, but it also significantly reduces the likelihood of grabbing the wrong parts. This solution is a zero-cost solution. It would require no new equipment to be purchased or additional operators on the line. All it requires is moving the existing carts around. This solution significantly reduces the chance of operator error, although it does not completely eliminate it.

Key: Orange: VGIC Blue: VGR

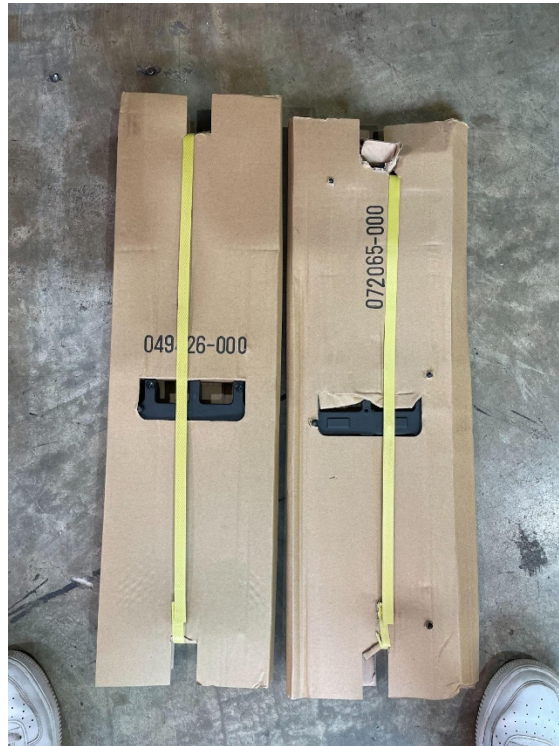
Figure 12: Grate Packaging Strap Depiction

Phase two of our solution is changing the color of the packaging strap on the grates. This will not only make it easier for the operator to see if the grates matched or if they have the right one, but the quality visual system would be able to signal the color difference and note if it is inaccurate. Viking receives the grates from a supplier. To change this color, they would have to contact their supplier. There would be no additional cost to change the color of the strap. After researching the vision system's capabilities, the team recommended yellow and black straps. The vision system compares contrast so black and yellow would be ideal. Also, this would allow the supplier to change only one of the boxes strap colors and not waste the yellow straps. The VGIC and VGR stations as mentioned in phase one would be labeled in these colors as well. Viking

stated that they have a few months lead time on grates from the supplier, so it would take a while for the new grates and system to take place. Figure 12 illustrates the current yellow packaging strap for both the VGR and the VGIC grates.
